Manhole Inspection Summary

Manhole # S31GG_045MH

Insp Date: 1/15/07 12:00 PM

Location Address: **218 LANVALE ST**

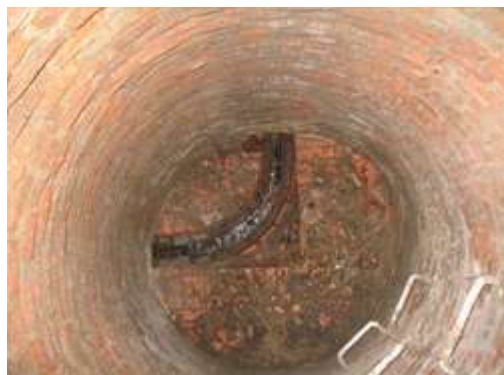
Top View

Evidence of surcharge - Bench debris.

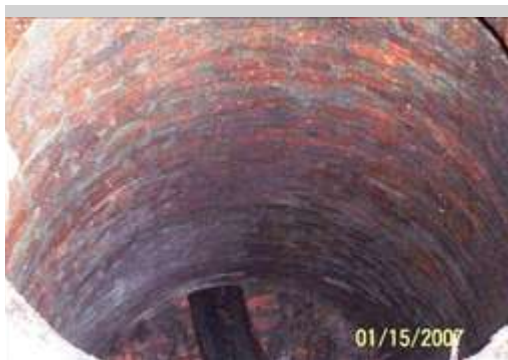
Defect

Adjustment deterioration, loose brick and infiltration. Corbel and Barrel infiltration - other side.

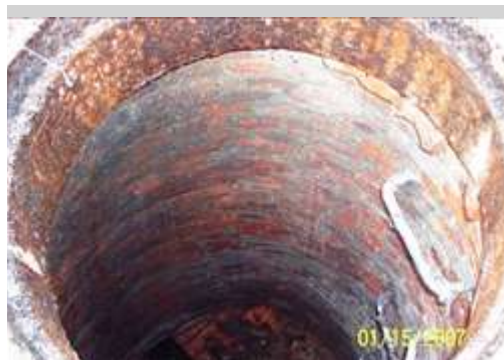
Defect

Adjustment deterioration, loose brick and infiltration. Corbel and Barrel infiltration.

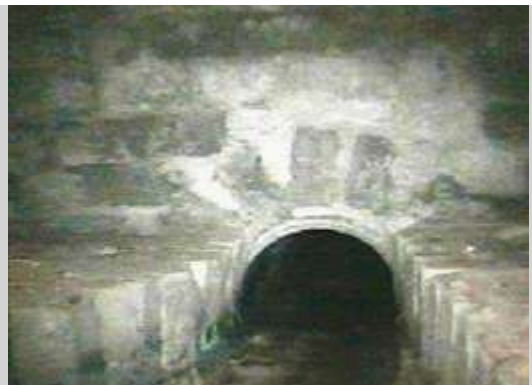
Pipe Out @ 12 O'Clock

Deposits: ☐ None ☒ **Mud** ☐ Sludge ☒ **Debris** ☐ Grease

Silt Depth: **0.5** (in.) Deposits Extent: **Light**

Infiltration: **Evidence** Pipe Seal Cond: **Unknown**

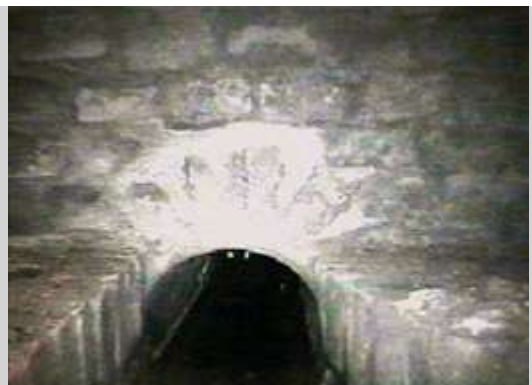
Pipe In @ 9 O'Clock

Deposits: ☐ None ☒ **Mud** ☐ Sludge ☒ **Debris** ☒ **Grease**

Silt Depth: **0** (in.) Deposits Extent: **Light**

Infiltration: **Evidence** Pipe Seal Cond: **Unknown**
